# Manhole Inspection Summary

Manhole # S01CC2006MH

**Location** Address: **6301 WESTERN RUN DR**

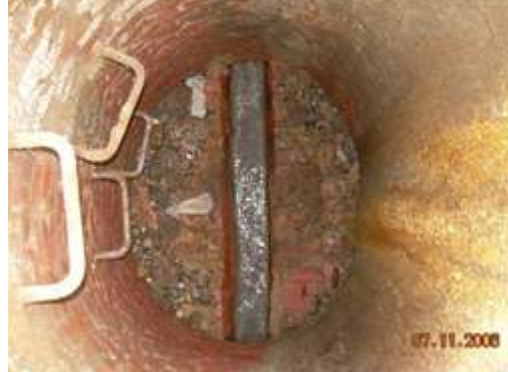
Top View

Corroded steps. Evidence of surcharge - Bench debris.

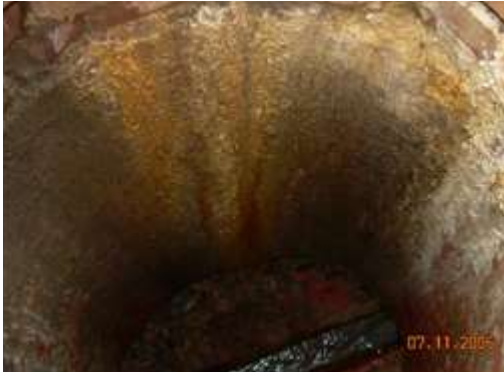
Defect

Adjustment and Corbel infiltration.

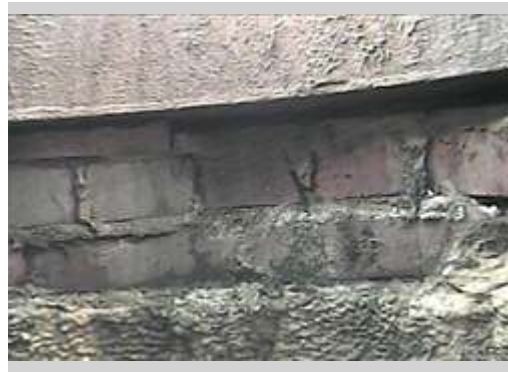
Defect

Frame leaks. Adjustment deterioration and infiltration. Corbel infiltration.

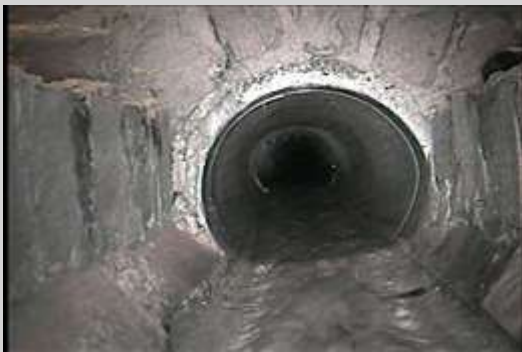
### 8 in. Circular Gravity Sewer Pipe Out @ 12 O'Clock

Infiltration: **Evidence** Pipe Seal Cond: **Cracked**

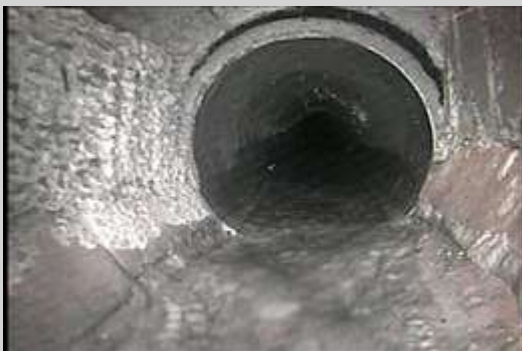
### 8 in. Circular Gravity Sewer Pipe In @ 6 O'Clock

Infiltration: **Evidence** Pipe Seal Cond: **Unknown**
